ARMY RESEARCH LABORATORY

Metallurgical Examination of M61A1 Breech Bolt Assembly Components

ARL-TR-684

The Naval Air Warfare Center (NAWC) requested the Army Research Laboratory (ARL) to perform a metallurgical investigation on 20mm M61A1 Gatling gun system breech bolt assembly components. An unused breech bolt assembly, and an individual locking block (a component of the breech bolt assembly) were both examined. Each part was taken from inventory at NAWCAD, Patuxent River. The Navy had experienced numerous failures of this system in practice gun mount testing and in service. Failures have coincided with the use of a recently developed more potent replacement for the 20mm M50 Series ammunition. This new ammunition is designated as 20mm PGU Series ammunition. The investigation performed by ARL concentrated on determining the conformance of each component to the governing specifications. The examination included high-voltage testing, visual examination, surface finish measurement, dimensional analysis, magnetic particle inspection, metallography, mechanical testing, chemical analysis, and coating measurements. Findings included a nonconforming surface finish upon the individual lo

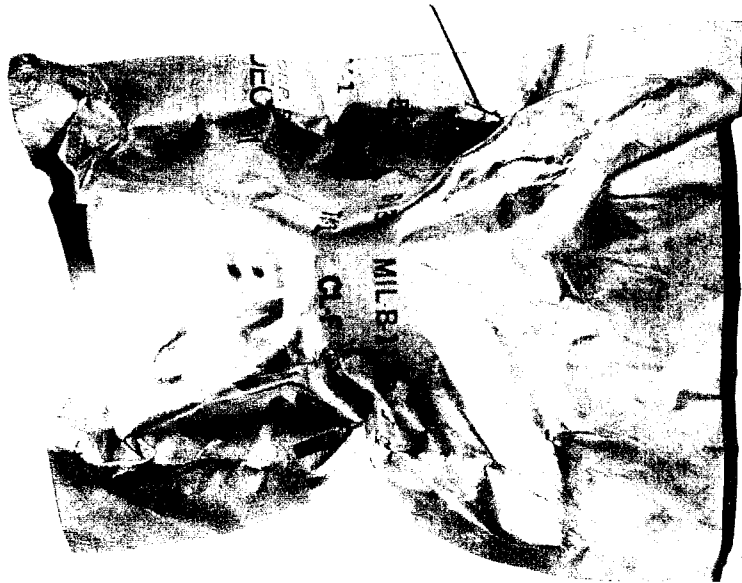
FIGURE 1 Breech bolt assembly in the as-received condition. Note puncture in protective packing, exposing part to environment. Reduced 20%.

The breech bolt assembly was received in the packing shown in Figure 1. Although the packing was punctured (see figure), visual inspection of the well lubricated component showed no sign of corrosion. Figures 2 through 4 show the top, side and end view of the breech bolt after being removed from its original package.

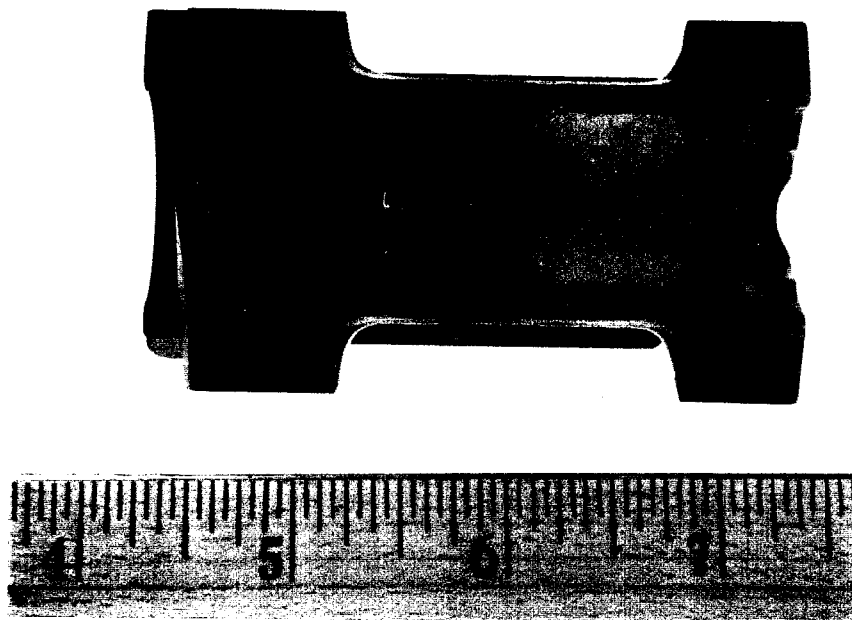
FIGURE 2 Top view of the as-received breech bolt assembly. Mag. 1x.

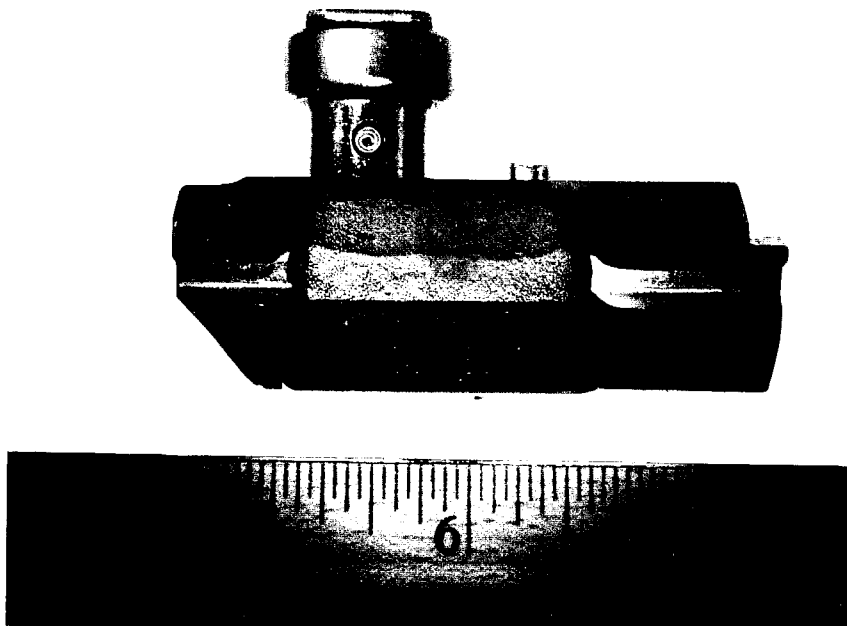
FIGURE 3 Side view of the as-received breech bolt assembly. Mag. 1x.

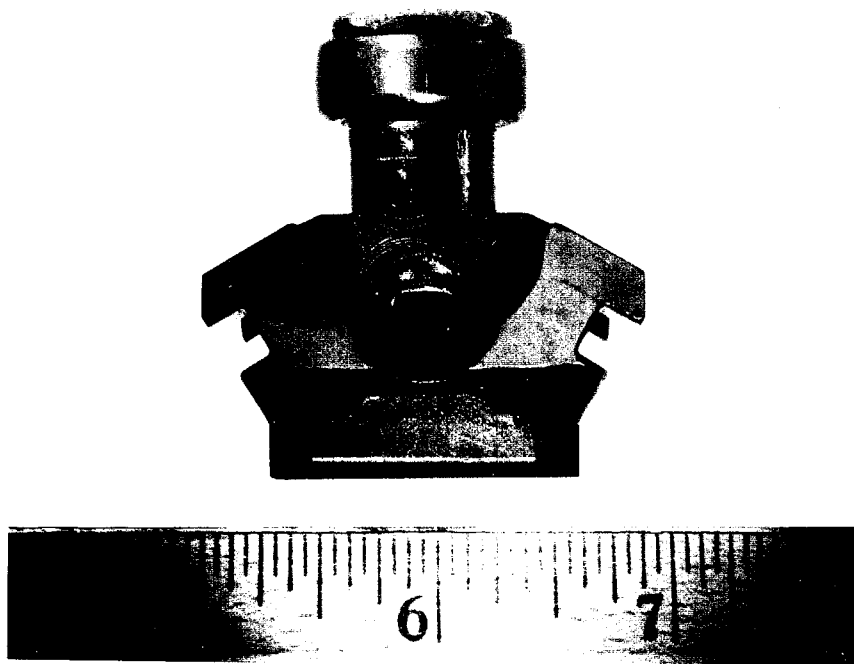
FIGURE 4 End view of the as-received breech bolt assembly. Mag. 1x.

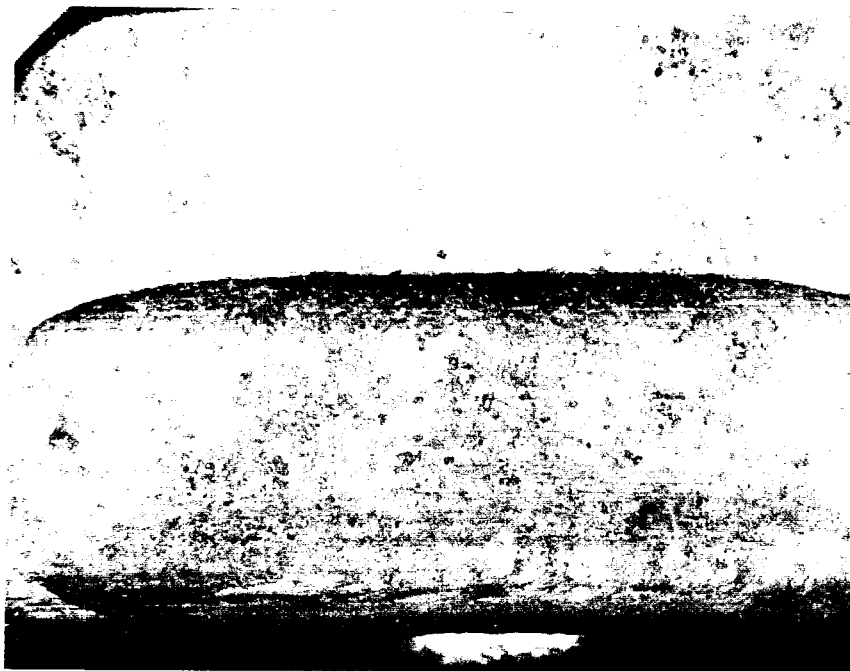
Visual inspection of the component revealed areas of corrosion along the top side, most heavily within the two machined recesses which act as potential sources of moisture entrapment. The low magnification macrographs of Figures 5 and 6 show the corrosion within each recess. Note the rust and pitting. The surface of the part was also rough exhibiting an as-forged profile. In addition, when the black oxide coating was scraped away, remnants of corrosion product could be observed beneath. This may have been the result of heat treat scale or corrosion if the part was set aside for a period of time before the sequence of manufacturing operations was complete. Figures 7 and 8 show the extent of the corrosion at higher magnification. This component was received by ARL-MD in an unlubricated condition, but was coated as specified within MIL-STD-171, (Finish No. 3.3.1, *Class I, alkaline oxidizing process for wrought iron, plain carbon and low alloy steels*). As stated within Section 1.1 of MIL-C-13924, this coating provides only very limited corrosion protection, under mildly corrosive conditions. Therefore, if the part is unlubricated, corrosion will most likely occur when the component is exposed to moisture from the environment during prolonged storage.

FIGURE 6 Optical macrograph of the other machined recess within the individual locking block, in the as-received condition. Note the rough surface profile and slight corrosion. Mag. 7.5x.

From a corrosion standpoint, a black oxide coating is not very protective, and is not recommended for parts subjected to long term storage. A coating of this type is designated because dimensional buildup cannot be tolerated for this application. However, if the part is subjected to long term storage, dimensional buildup may be noted due to the oxides formed by corrosion. A supplementary water displacing preservative coating such as MIL-C-16173, Grade 3 or VV-L-800 should be specified for corrosion protection.

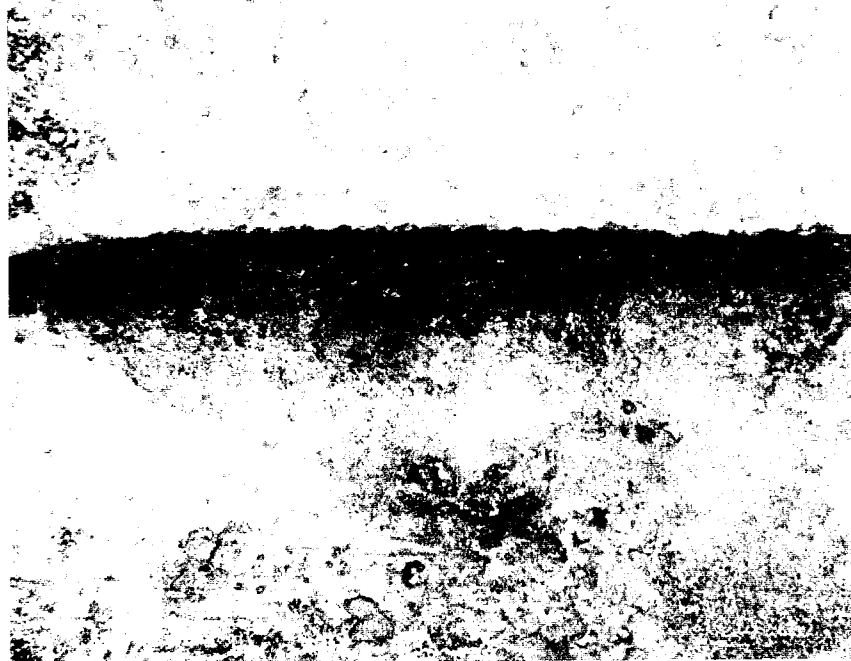
FIGURE 7 A higher magnification optical macrograph of Figure 5 showing extent of roughness and corrosion. Mag. 12x.

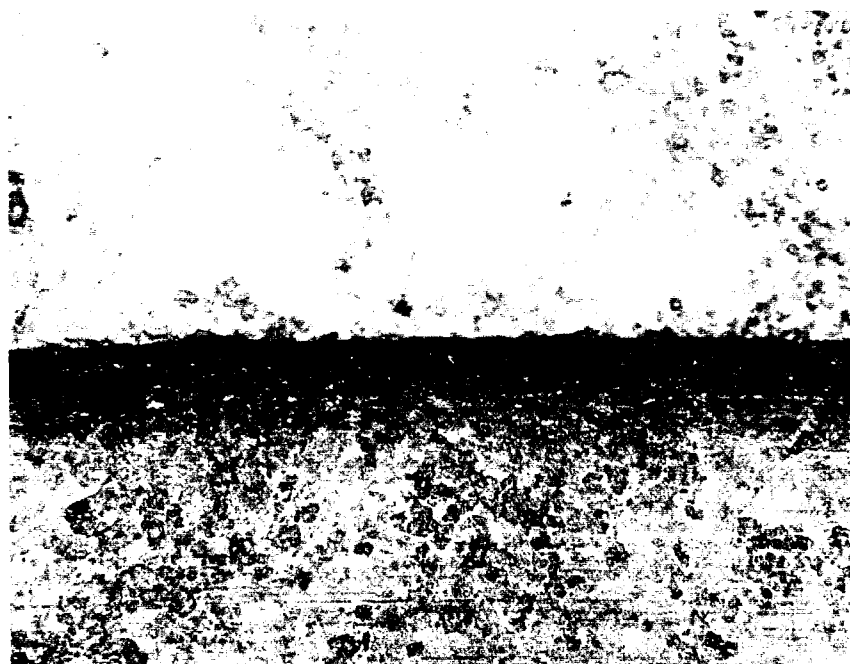
FIGURE 8 A higher magnification optical macrograph of Figure 6 showing extent of roughness and corrosion. Mag. 12x.

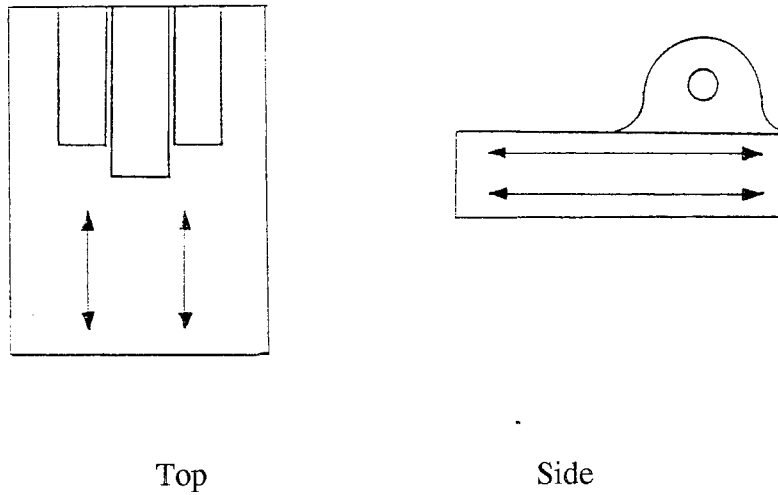
FIGURE 9 A schematic showing directions of surface finish measurement on the individual locking block.

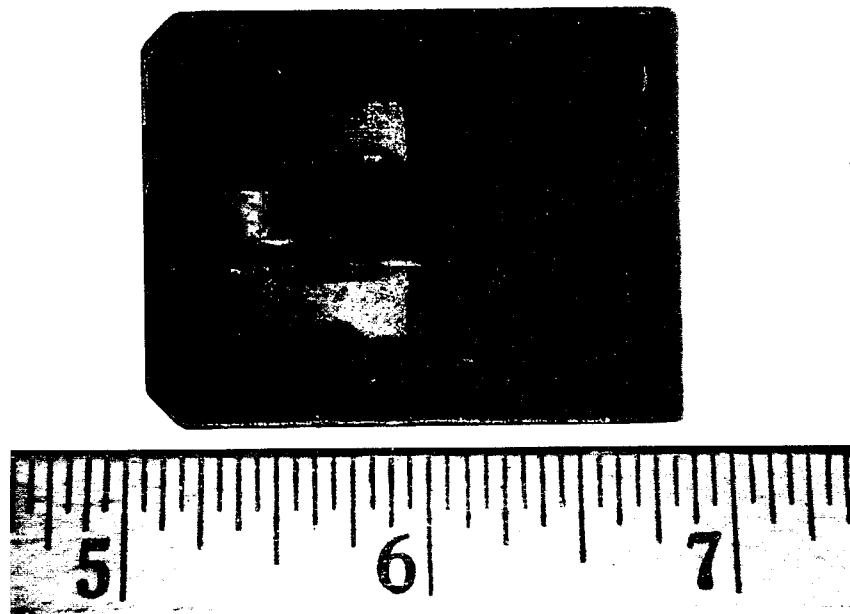
FIGURE 10 Top view of the individual locking block showing excessive machine marks. Surface finish was determined to be out of specification. Mag. 1.5x.

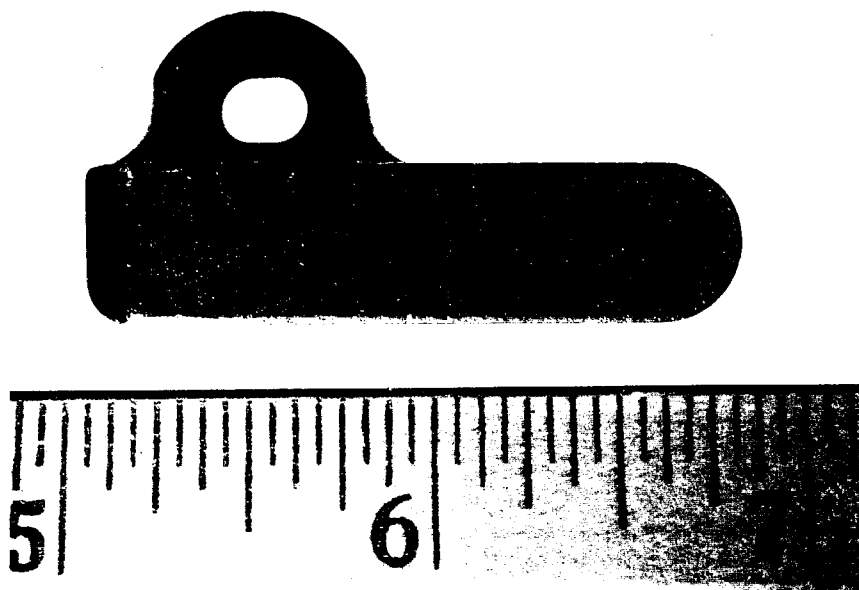
FIGURE 11 Side view of the individual locking block showing excessive machine marks. Surface finish was determined to be out of specification. Mag. 1.5x.

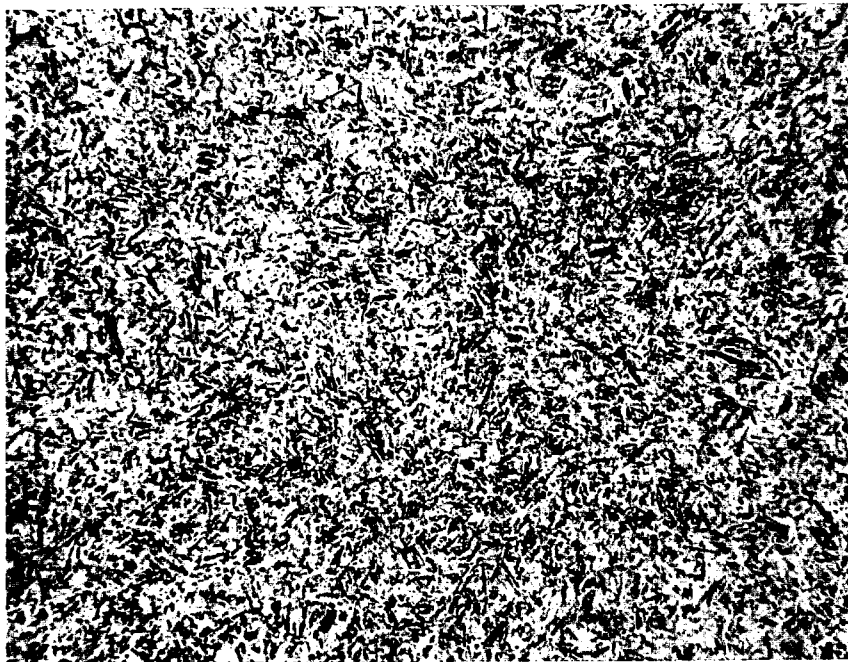
The sectioned portion of the locking block which was macroetched to verify grain flow, was also utilized to examine the microstructure of the material. A 4% nital etchant was applied to the polished surface, to reveal the fine tempered martensitic structure shown in Figure 14. This microstructure is consistent with the prior heat treatment (austenitize, quench and temper). Section 3.5 of MIL-F-7190 states that, *"the structure of the part shall be essentially uniform and free from defects."* The microstructure displayed no inherent material defects, and the material conformed to this requirement. However, noted around the periphery of the component was a layer of decarburization. Figure 15 shows a representative region of this decarburization. Note the distinct ferritic decarburized layer, the transition zone of ferrite and lower-carbon martensite, and the normal matrix of tempered martensite. Section 3.3.3.1 of MIL-H-6875 states that,

FIGURE 14 Individual locking block microstructure (AISI 4140) consisting of fine tempered martensite, typical of prior heat treatment. 4% nital. Mag. 300x.

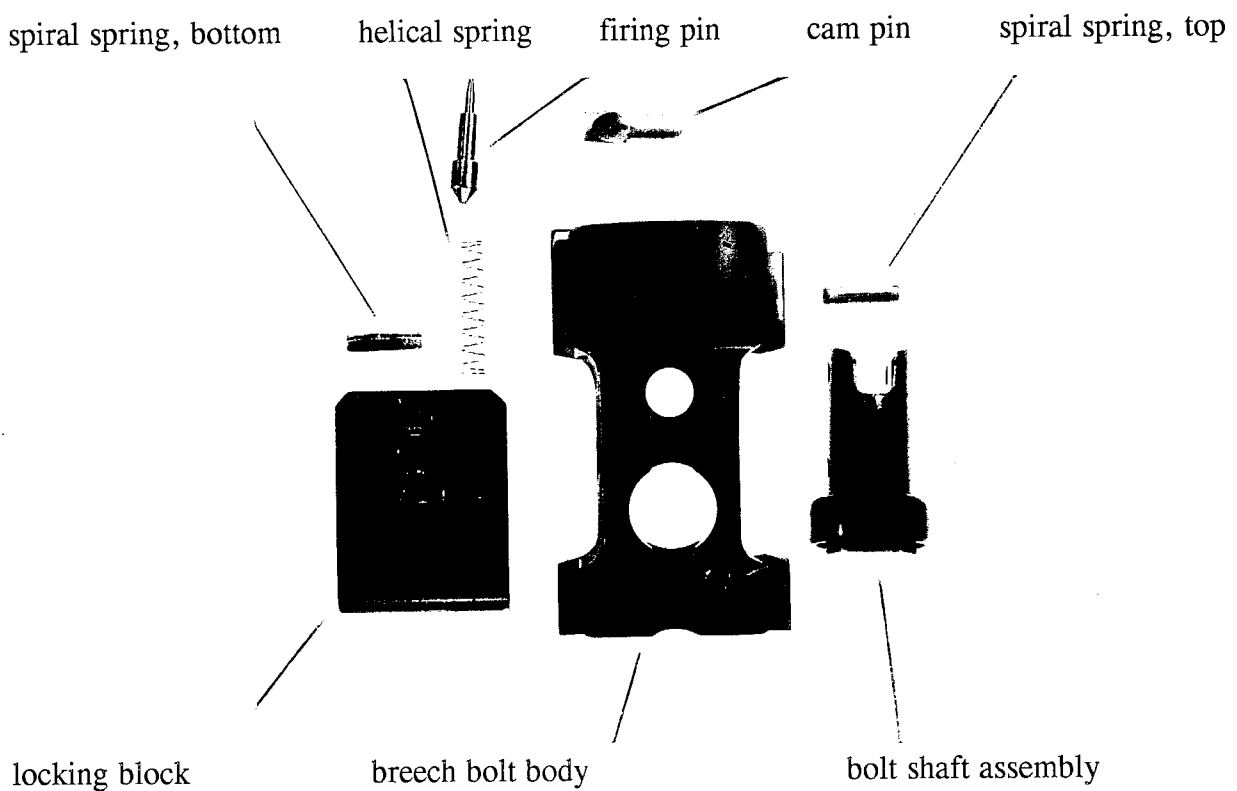
FIGURE 19 Macrograph of the disassembled breech bolt assembly. Reduced 50%.

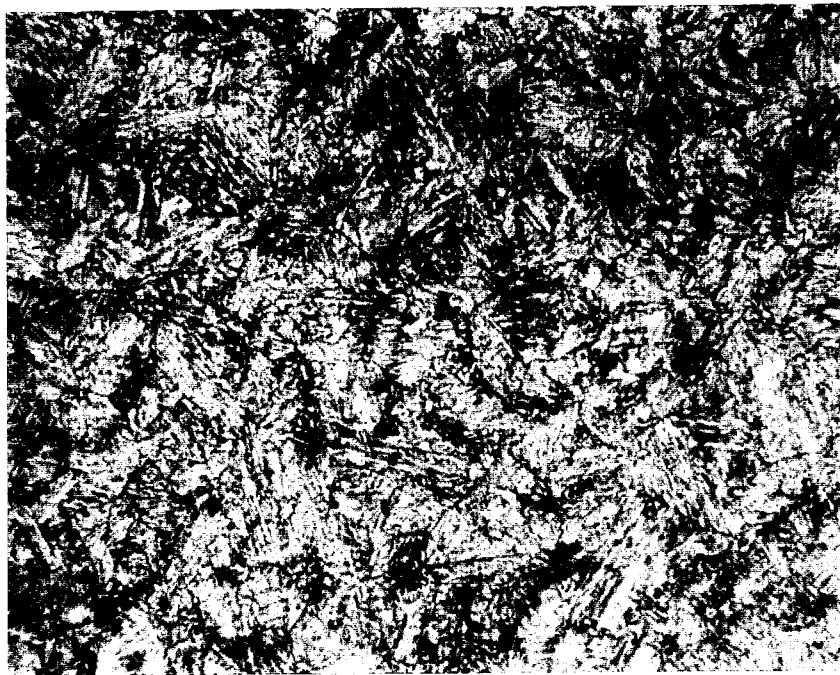
The sectioned and mounted portion of the firing pin was subsequently etched with 4% nital, in order to reveal the microstructure. The structure consisted of aged low-carbon martensite, as shown in Figure 23. This structure was consistent with the prior heat treatment (solution-anneal, age, air cool). Section 3.6.3 of MIL-S-46850 states that for Grade 300, Type III material, *the grain size shall be predominantly six or finer with grains as large as four permissible in accordance with the applicable ASTM E 112 chart*. The 100x micrograph of Figure 24 shows the grain size to be between seven and eight, in conformance to the governing specification. No internal or surface defects were noted within the microstructure.

FIGURE 23 Firing pin microstructure (Maraging, Grade 300) consisting of low carbon martensite, consistent with prior heat treatment. Fry's reagent. Mag. 300x.

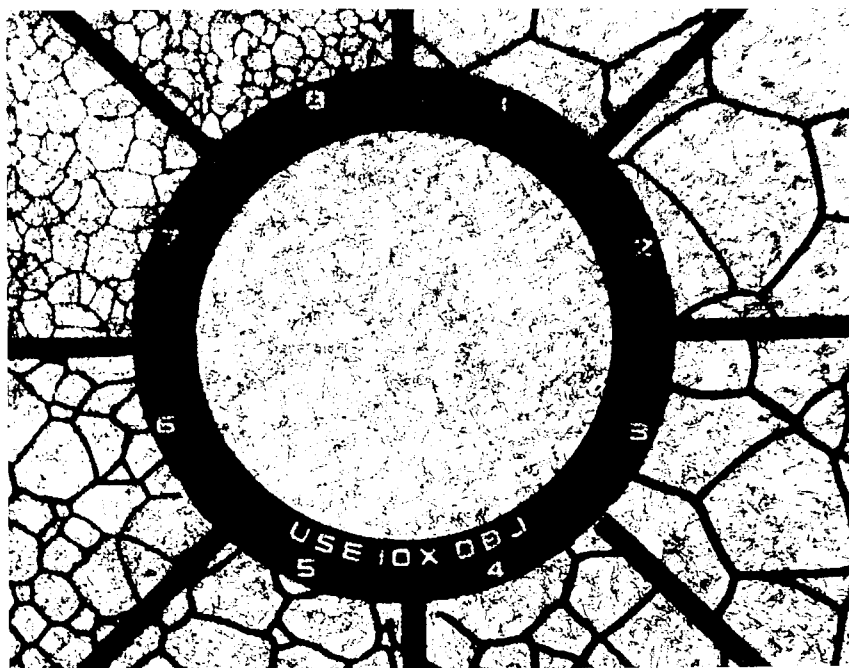
FIGURE 24 Grain size of the firing pin. Spec. MIL-S-46850 requires a grain size of six or finer (four is permissible). From micrograph, grain size is between six and seven. Fry's reagent. Mag. 100x.

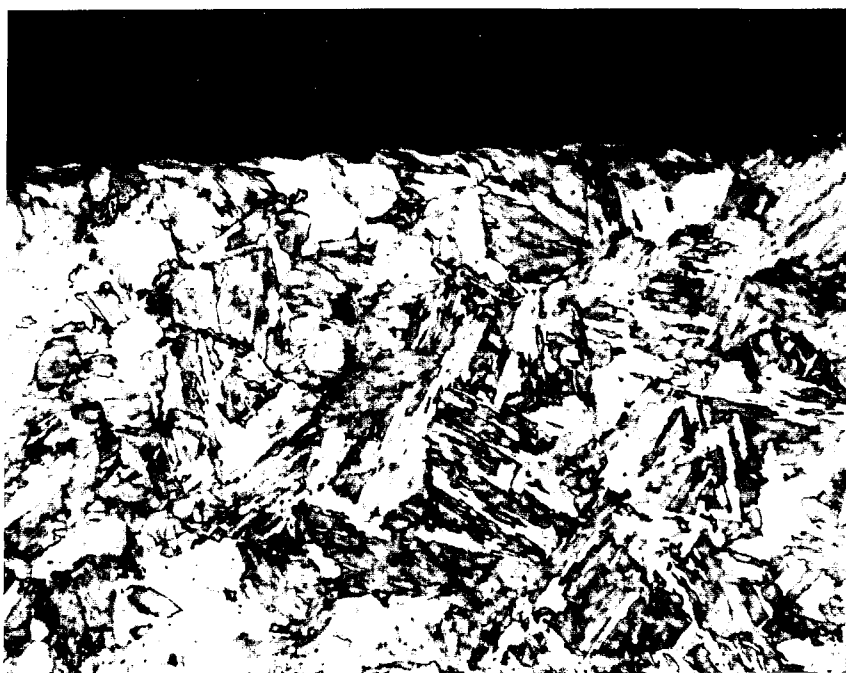
FIGURE 28 Microstructure of the region which was supposed to be nitrided on the bolt shaft, bottom. A darkened case was not noted on the surface of the component. Fry's reagent. Mag. 300x.

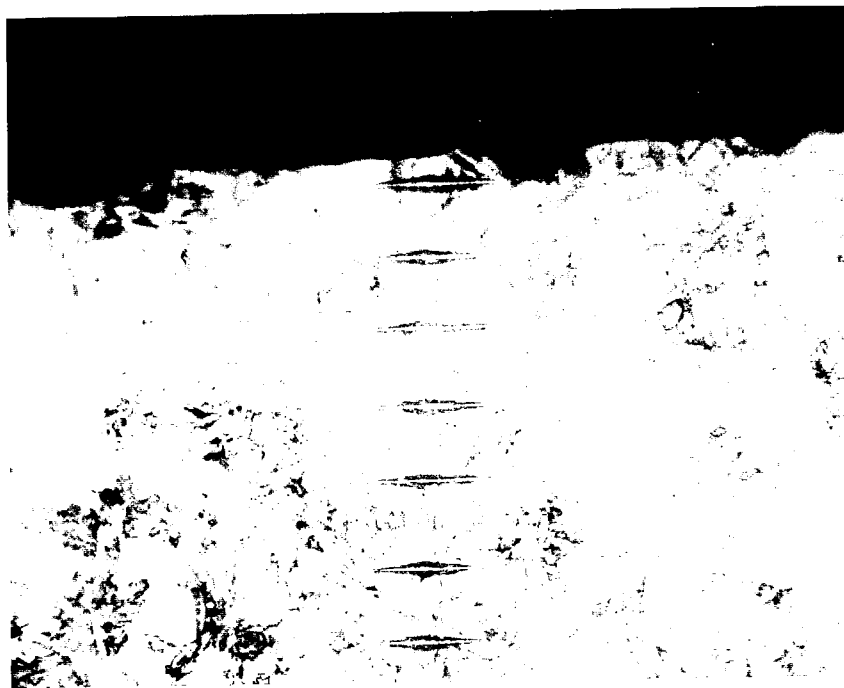
A Knoop microhardness profile was conducted to determine the presence of a nitride case on the mounted sample, in the as-polished condition. No significant hardness gradient was noted as shown in Table 19 of Appendix D. From the micrograph of the etched sample shown in Figure 29, the reading closest to the surface should be completely within the case, assuming a 0.0005 inch case depth. For a case depth of 0.001 inch, the first two readings would be fully within the nitrided case. Each of the readings supposedly within the nitrided case converted to an HRC of 50-55, not HRC 60, as specified.

FIGURE 29 Microhardness profile conducted to verify nitrided case on the "After-Market" bolt shaft, bottom. No significant hardness gradient was noted. Fry's reagent. Mag. 300x.

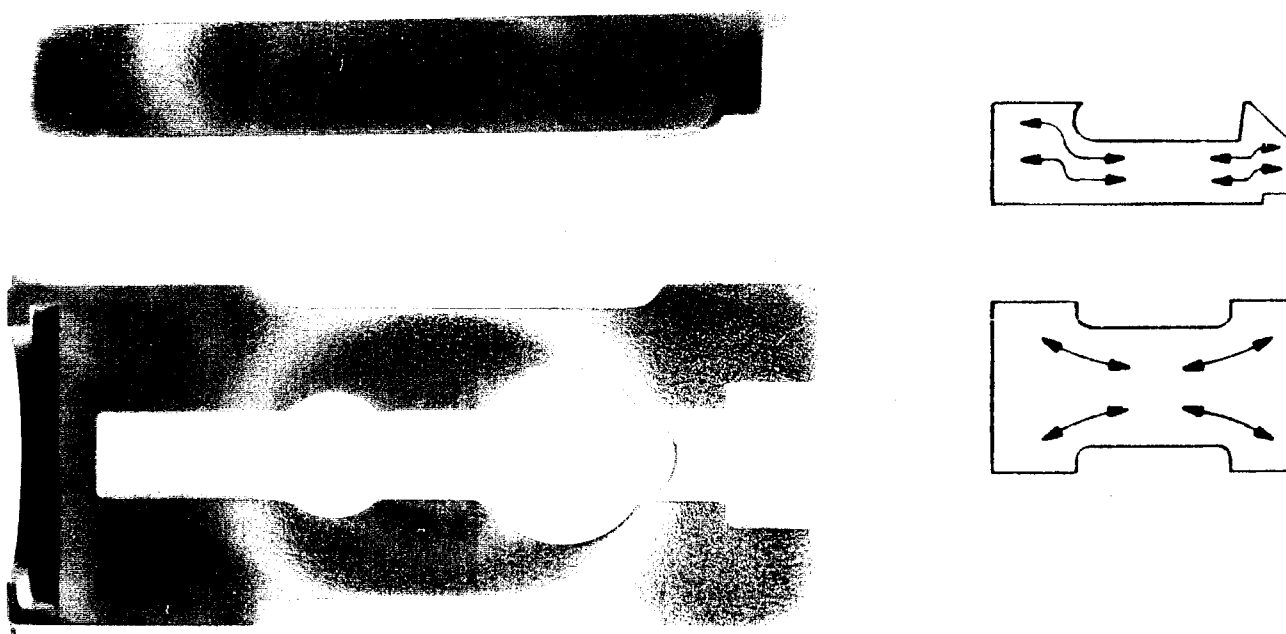
FIGURE 30 Breech body grain flow with schematic of allowable grain flow per drawing 11691423. Photos Mag. 1.5x

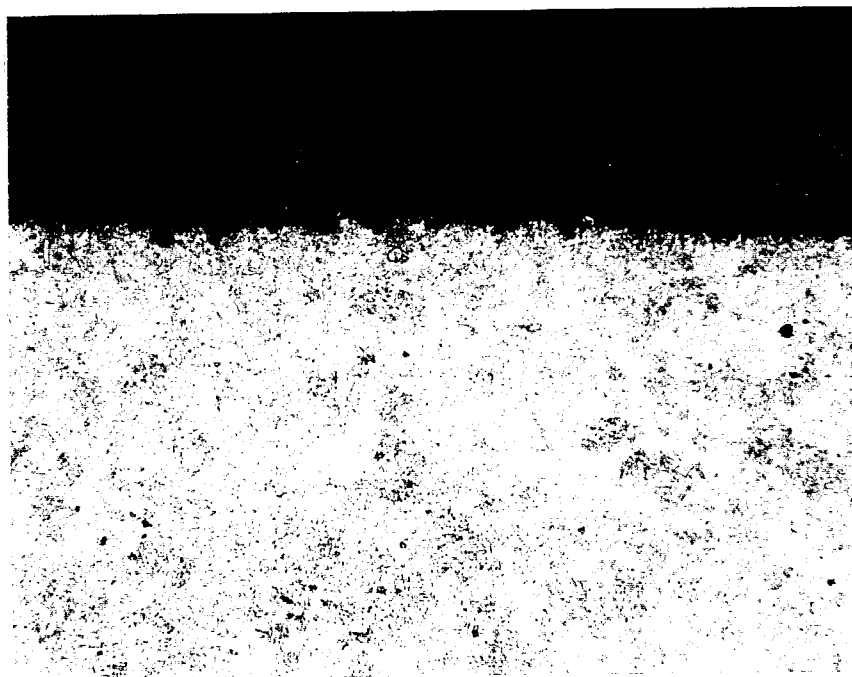
The sectioned portion of the locking block which was macroetched to verify grain flow, was also utilized to examine the microstructure. A 4% nital etchant was applied to the polished surface, to reveal a fine tempered martensitic structure. This microstructure was consistent with the prior heat treatment (austenitize, quench and temper). Figure 14, although that of the other locking block, was typical of the microstructure noted within this locking block. The structure of the part was free from deleterious defects, and, in contrast to the other locking block, the outer surface contained no signs of decarburization (Figure 36).

FIGURE 36 Surface microstructure of assembly locking block showing no signs of decarburization. Compare to Figure 15 (decarburized surface of the individual locking block). Mag. 250x.

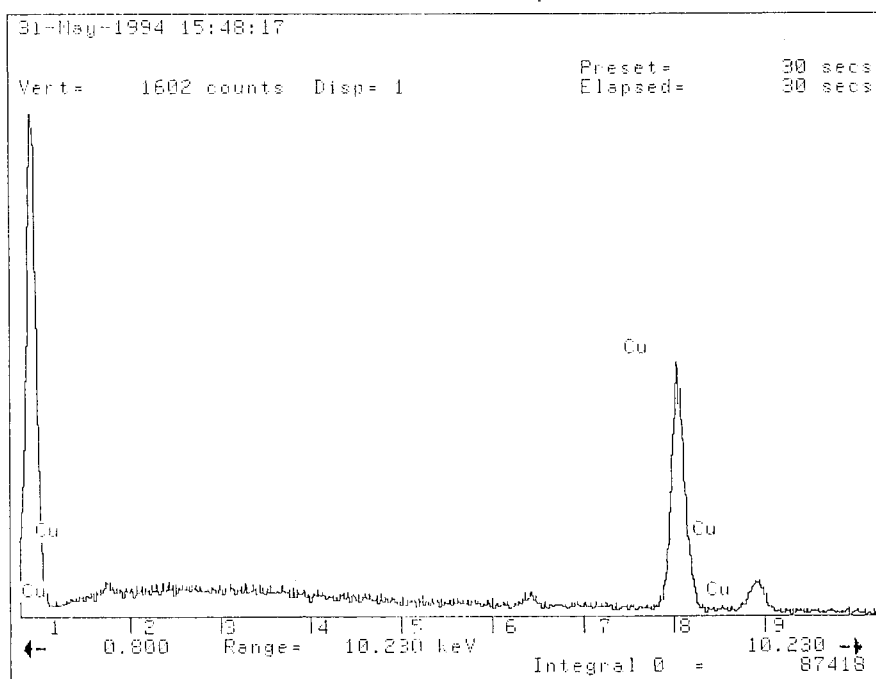
EDS of the coating on the "Top" spring, confirmed that copper plating was utilized. The iron peak represents the base metal, while the silicon and cobalt peaks represent elements found within the chemistry of the base material. EDS of the coating of the "Bottom" spring also confirmed the presence of copper plating, as shown in Figure 42.

FIGURE 42 Representative EDS spectrum of the plating on the spiral spring pins, verifying that copper was utilized, as represented by the copper peaks.

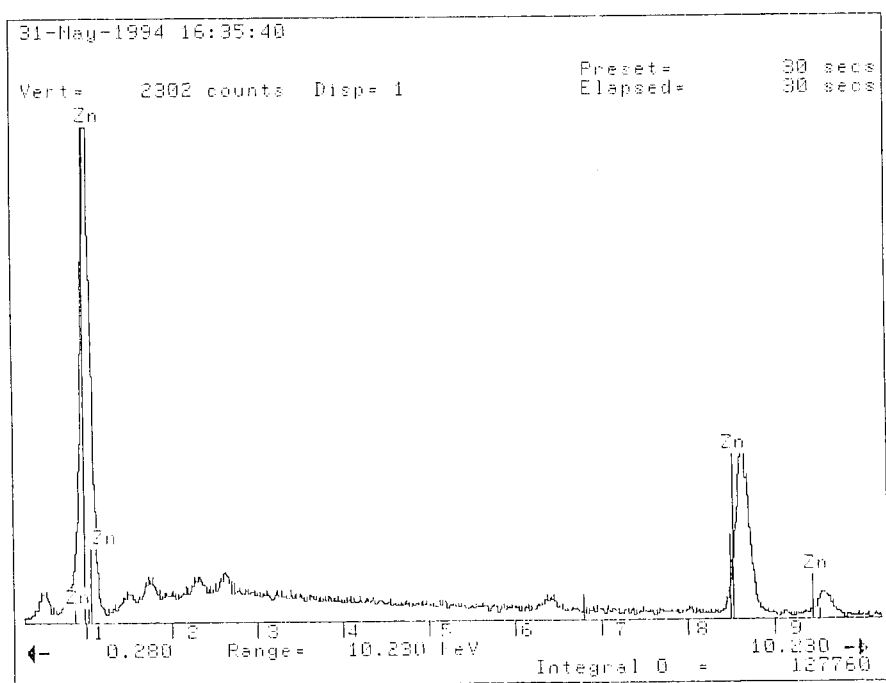
FIGURE 44 EDS spectrum of the plating on the helical compression spring verifying that zinc was utilized instead of cadmium, as represented by the zinc peaks.
